ASBESTOS ASSES SURVEY

H-K Building  
Project Number: 0980193E  
Project: G. HEILEMAN BREWERY "E"  
Date Inspected: 03/23/89  
Inspector: MARK VOTH

Building Number: 05/05A  
Building Name: STORAGE/CREDIT UNION  
SEATTLE, WASHINGTON 98134  
Building Type: STORAGE  
Year Constructed: 1933

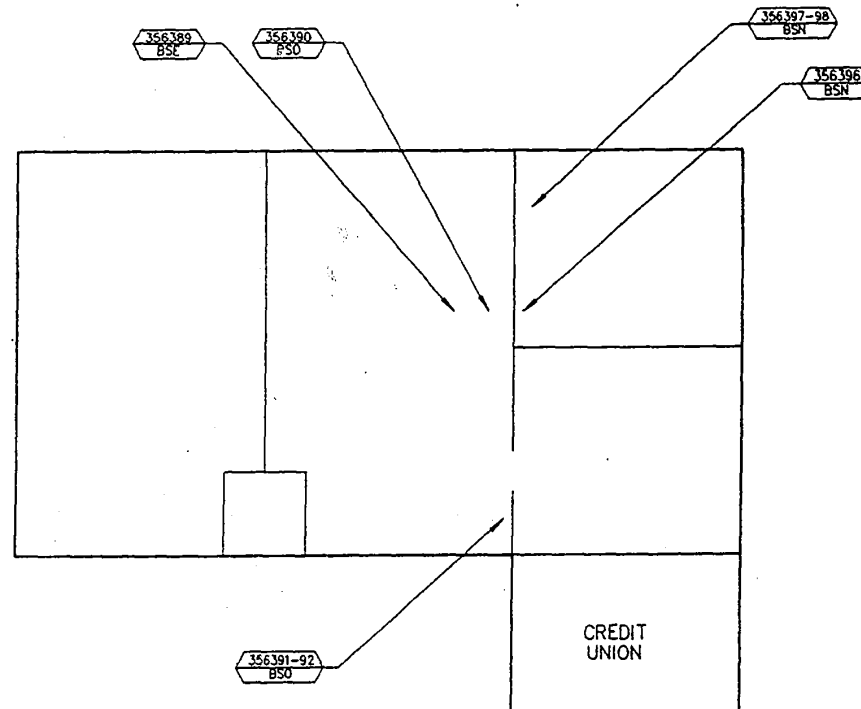
FIRST FLOOR

The materials are in good condition with minor contact and water damage. The materials are approximately 8' to 20' from the floor. At a minimum, it is recommended that the materials be repaired and monitored. If removal is planned, glove bag removal procedures are recommended. This appears to be a high traffic area.

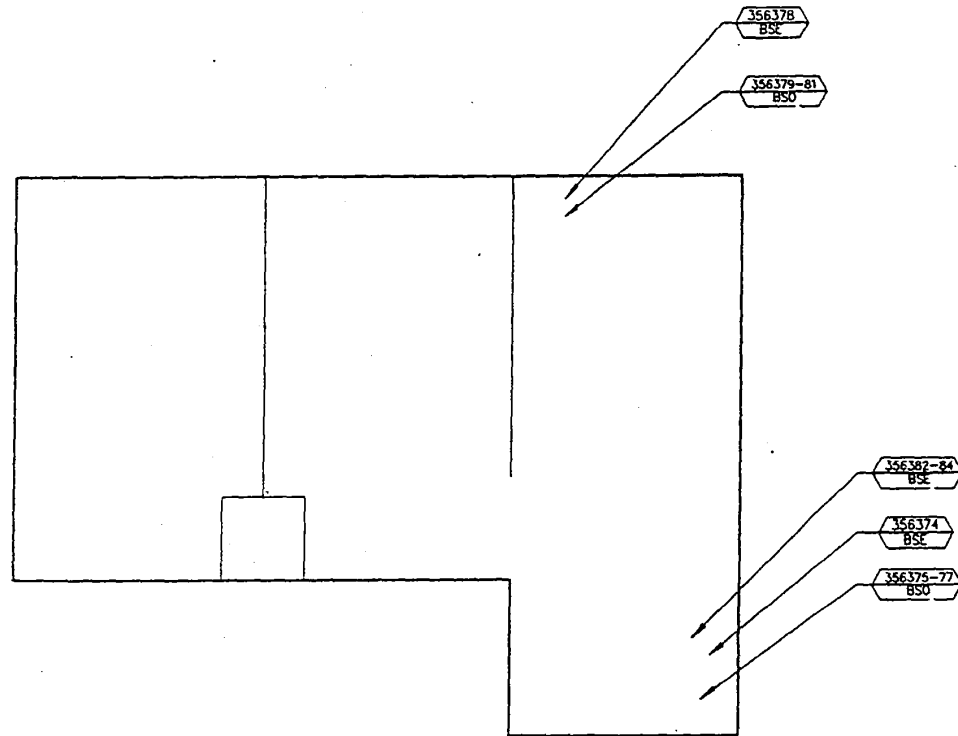
THIRD FLOOR

The materials are in good condition with minor contact and water damage. The materials are approximately 2' to 10' from the floor. At a minimum, it is recommended that the materials be repaired and monitored. If removal is planned, gross removal procedures are recommended. This appears to be a low traffic area.

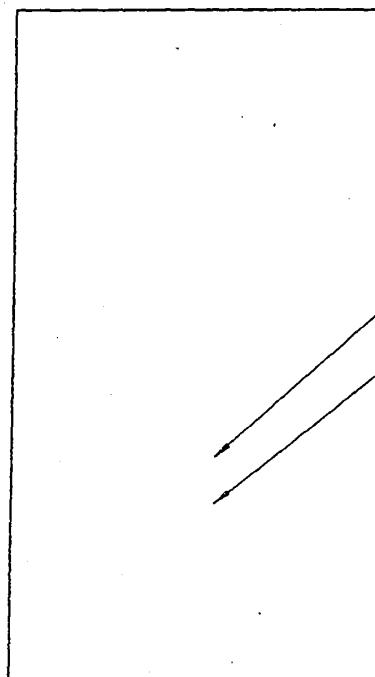
SIXTH FLOOR

The materials are in good to fair condition with minor contact and water damage. The materials are from floor level to 4' high. At a minimum, it is recommended that the materials be repaired and monitored. If removal is planned, glove bag removal procedures are recommended. This appears to be a low traffic area.
